FACILITY STUDY REPORT

WHITEFORD AGRICULTURAL SCHOOLS
ELEMENTARY + MIDDLE/HIGH SCHOOLS
6655 CONSEAR ROAD
OTTAWA LAKE, MI 49267

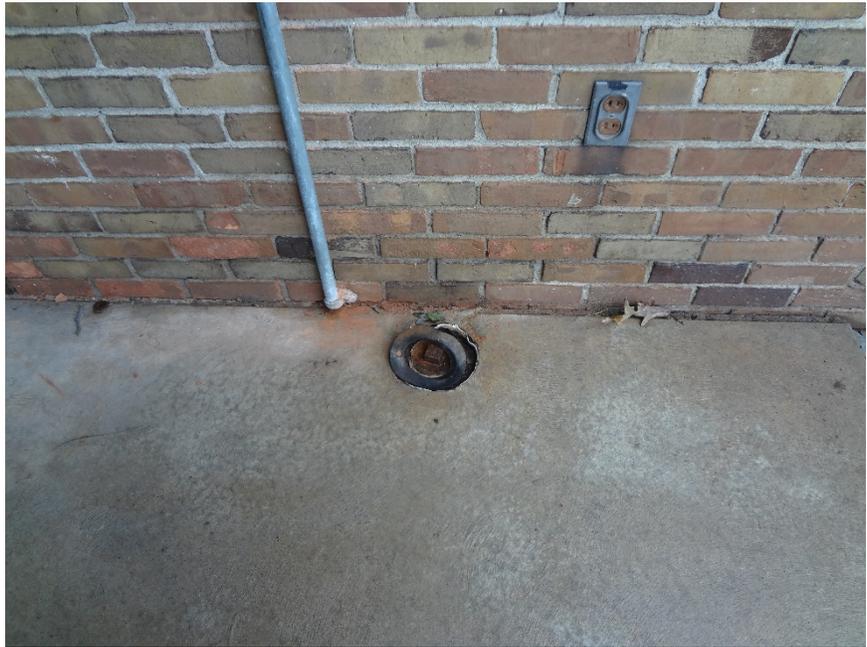
1. CLEANOUT CASKET DRYROTTED + DISLODGED FROM CONCRETE ENCLOSURE
- REPLACE RUBBER GASKET AND PROVIDE CLEANOUT COVER

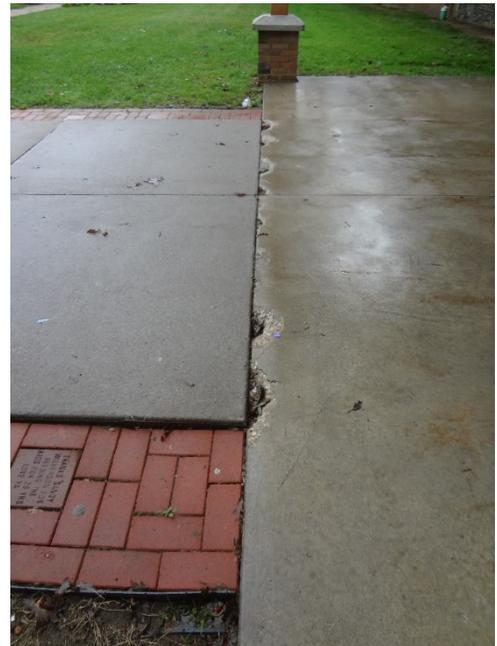
2. BROKEN CONCRETE ENTRY SLAB @ CONCRETE SIDEWALK - MAIN ENTRY
- REPLACE BROKEN CONCRETE

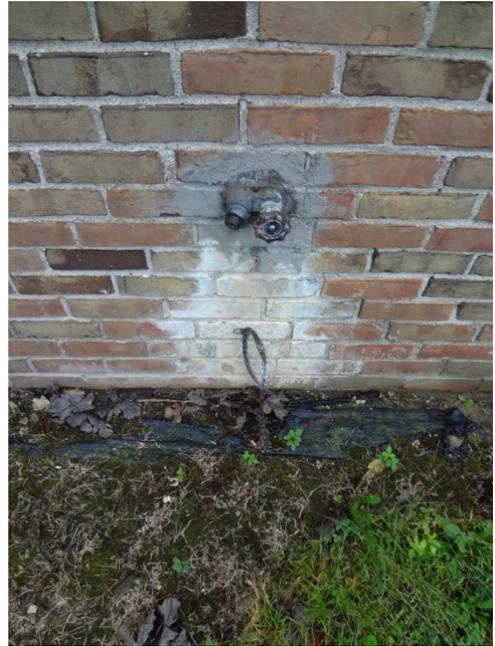
3. EXTERIOR WATER BIB, RESIDUE ON FACE OF BRICK INDICATES LEAKING WATER
- CLEAN ORGANIC MATTER FROM BRICK, INSPECT WATER BIB AND REPAIR AS REQUIRED

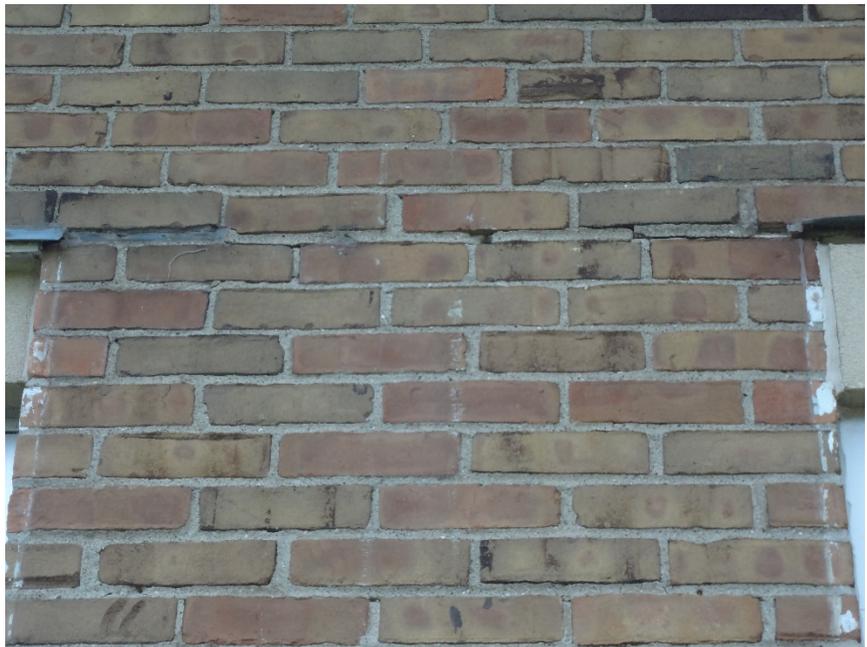
4. ERODED + LOOSE GROUT, TYPICAL AT DOOR + WINDOW FLASHING
- CLEAN & REPOINT MASONRY AS NEEDED FOR DAMAGED JOINTS. INSPECT ANNUALLY.

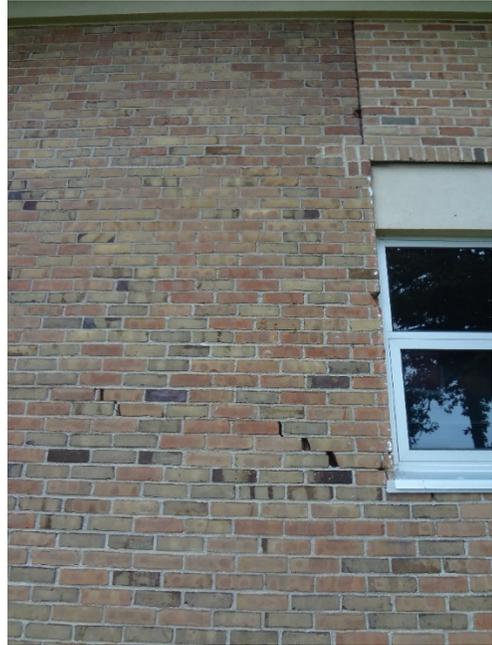
5. BROKEN + MISSING BRICK THROUGHOUT AREA OF FAÇADE
- CLEAN & REPOINT MASONRY AS NEEDED. INSPECT ANNUALLY.

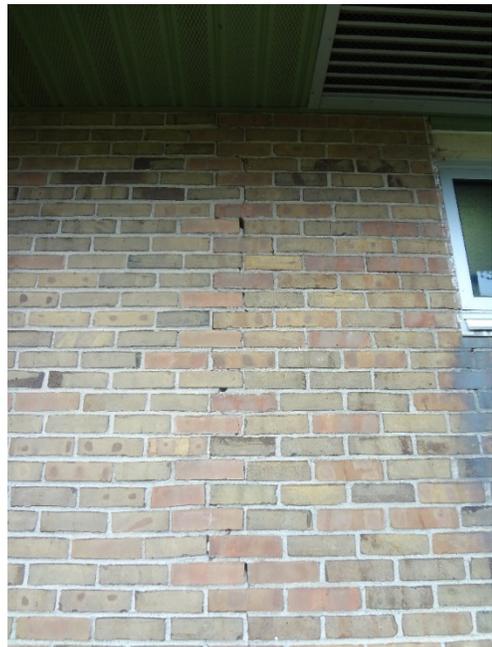
6. BROKEN + MISSING BRICK + ERODED GROUT THROUGHOUT AREA OF FAÇADE
- CLEAN & REPOINT MASONRY AS NEEDED FOR DAMAGED JOINTS. INSPECT ANNUALLY.

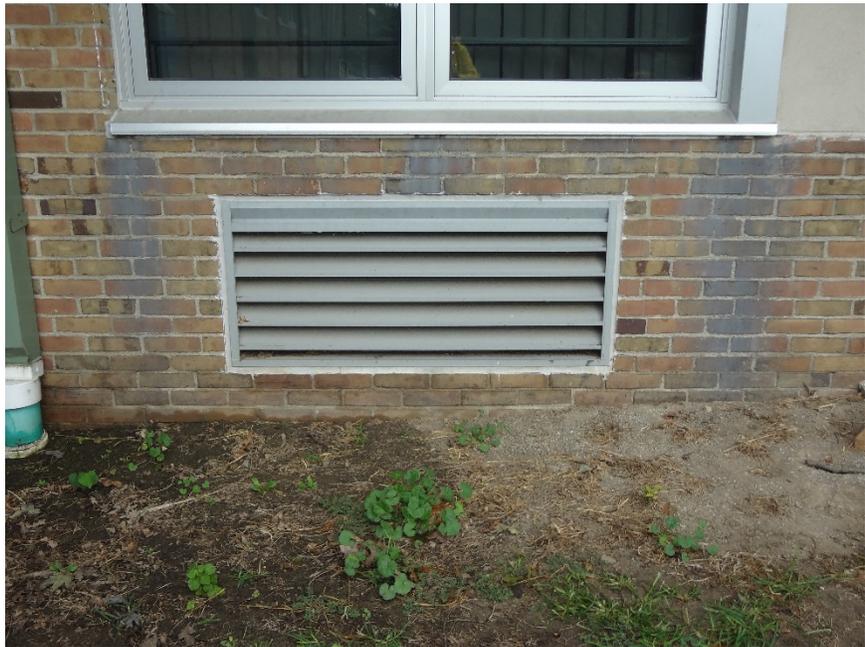
7. ALUMINUM STAINS ON BRICK, TYPICAL AT ALL WINDOWS THROUGHOUT FACILITY
- CLEAN AND SEAL MASONRY AS NEEDED IN ALL SIMILAR LOCATIONS.

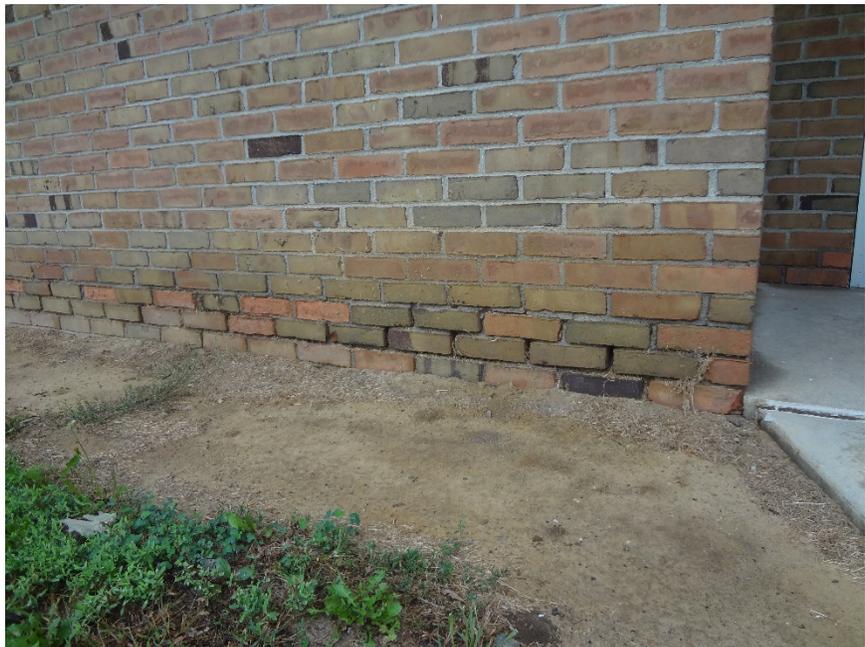
8. BROKEN + ERODED GROUT, 2'-0" ABOVE GRADE AND BELOW, TYPICAL
- CLEAN & REPOINT MASONRY AS NEEDED FOR DAMAGED JOINTS. INSPECT ANNUALLY.

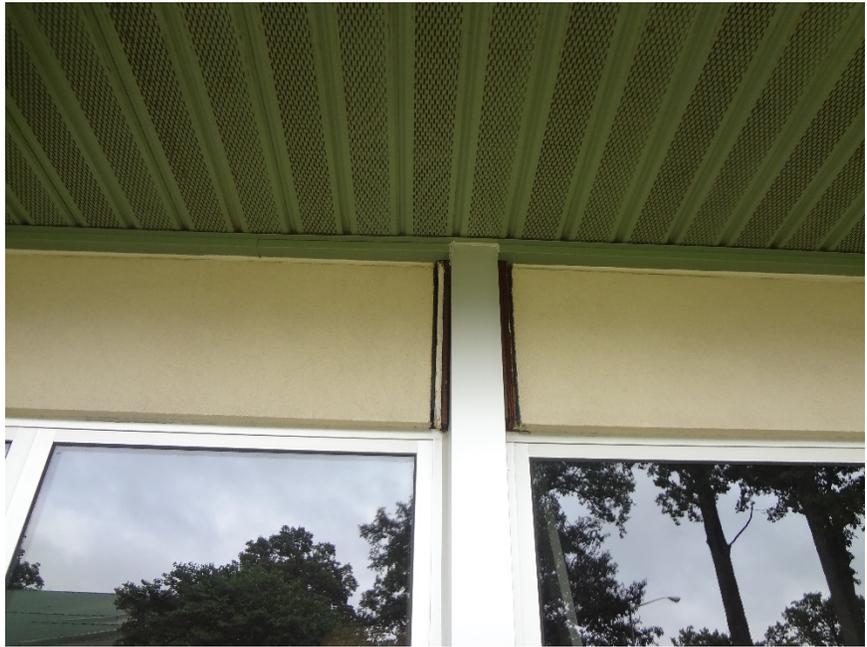
9. PLYWOOD + GYPSUM BOARD EXPOSED TO EXTERIOR ELEMENTS
- CUT-BACK PLYWOOD AND GYPSUM, INFILL OPENING FOR WEATHER TIGHTNESS

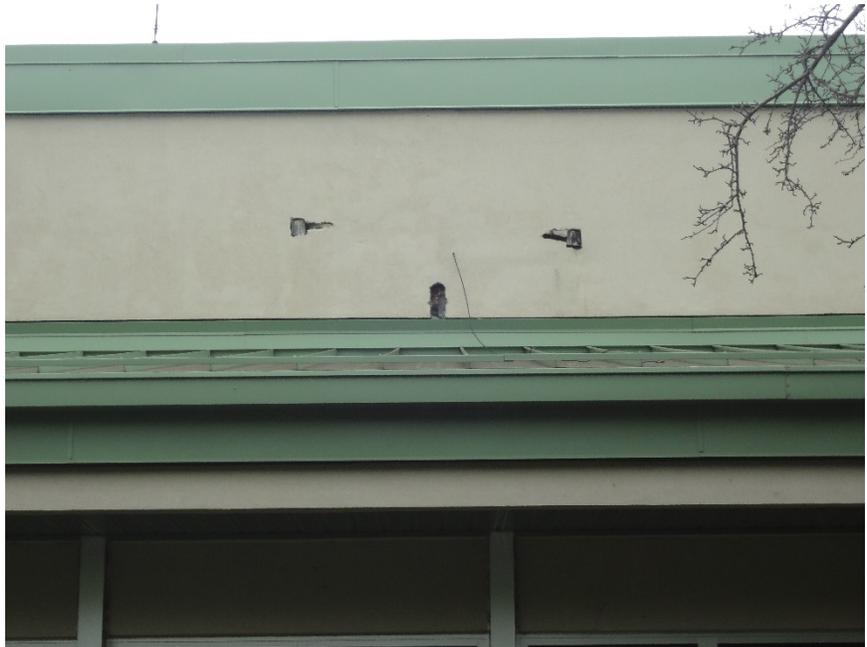
10. PUNCTURES IN EIFS, ALLOWING AIR + WATER INFILTRATION INTO ROOF CAVITY
- PATCH AND REPAIR EIFS, FINISH TO MATCH EXISTING

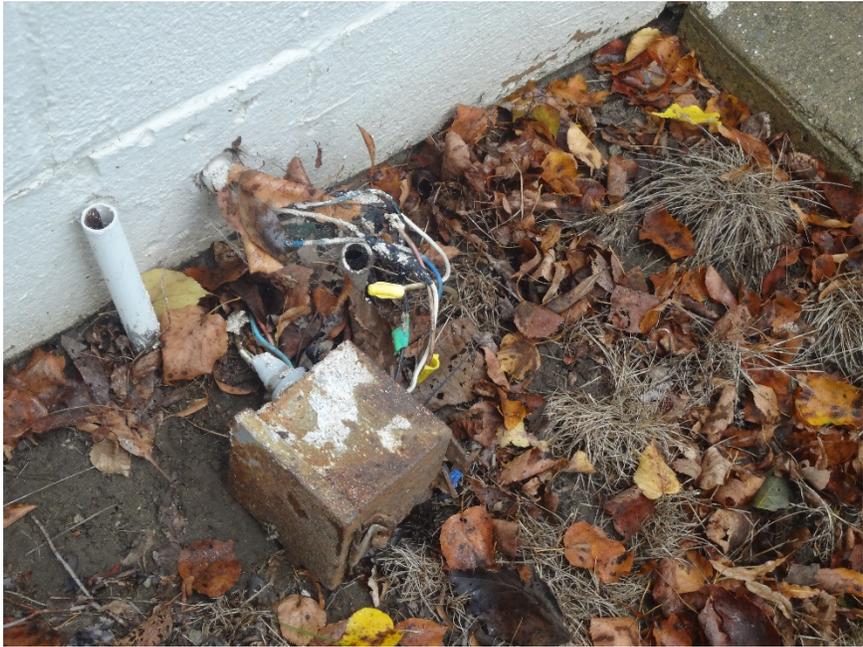
11. BROKEN CONDUIT + EXPOSED WIRING OF ABANDONED JUNCTION BOX
- DISCONNECT JUNCTION BOX AND CAP ELECTRICAL AS REQUIRED

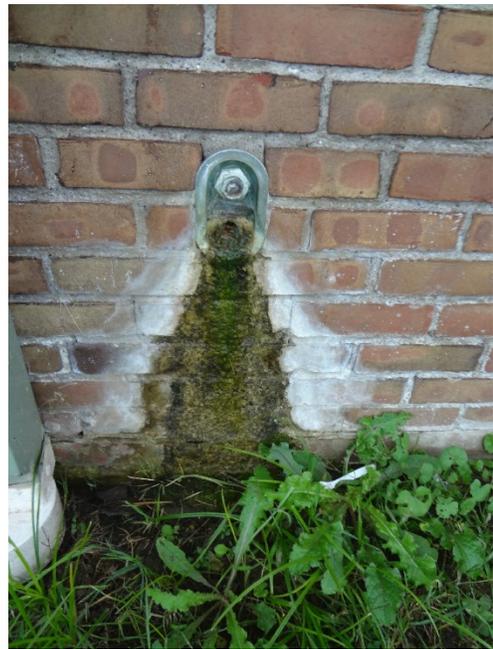
12. ORGANIC GROWTH + STAINING BELOW BROKEN WATER BIB
- CLEAN ORGANIC MATTER FROM BRICK, INSPECT WATER BIB AND REPAIR AS REQUIRED

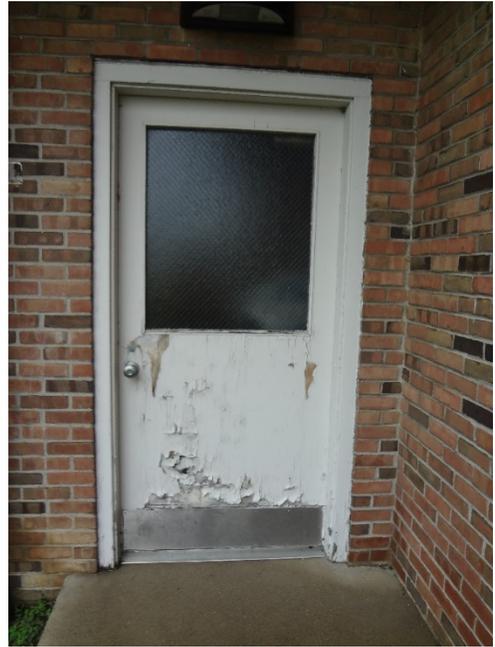
13. PEELING PAINT + DAMAGED WOOD SERVICE DOOR
- REPLACE EXISTING WOOD SERVICE DOOR WITH NEW STEEL DOOR AND FRAME

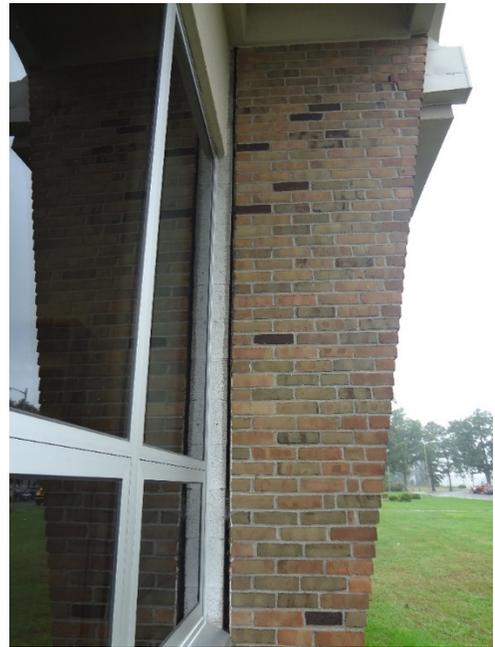
14. OPEN EXPANSION JOINT, SHOULD BE FILLED WITH BACKER ROD + SEALANT
- INSTALL BACKER ROD AND CAULK AROUND FRAME, INSPECT WEATHERSTRIPPING

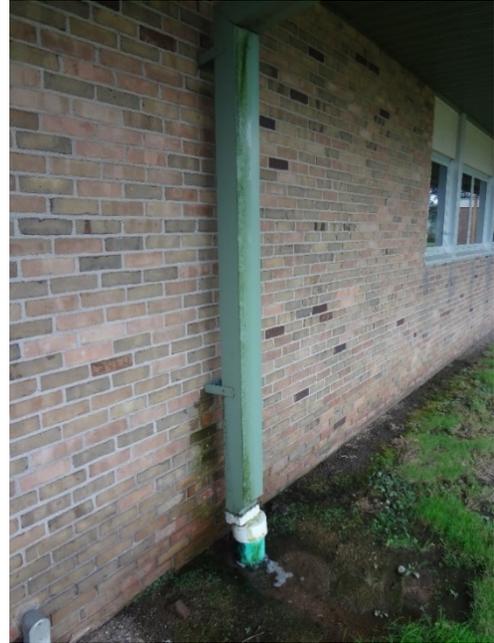
15. WATER LEAKING FROM TOP OF DOWNSPOUT, ORGANIC GROWTH ON FACE
- CLEAN, INSPECT AND REPAIR DOWNSPOUT CONNECTION AS REQUIRED

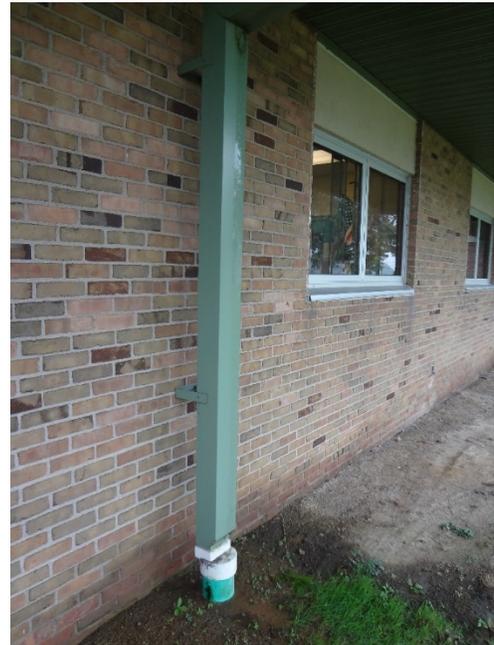
16. ANOTHER DOWNSPOUT LEAKING FROM SEAM AT TOP OF DOWNSPOUT
- CLEAN, INSPECT AND REPAIR DOWNSPOUT CONNECTION AS REQUIRED

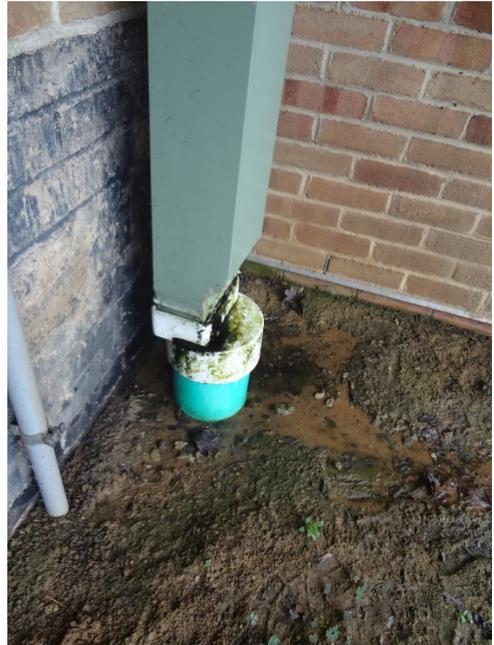
17. OVERFLOWING DOWNSPOUT AT CONNECTION TO UNDERGROUND LEADER, TYPICAL
- CLEAN, INSPECT AND REPAIR DOWNSPOUT CONNECTION AS REQUIRED

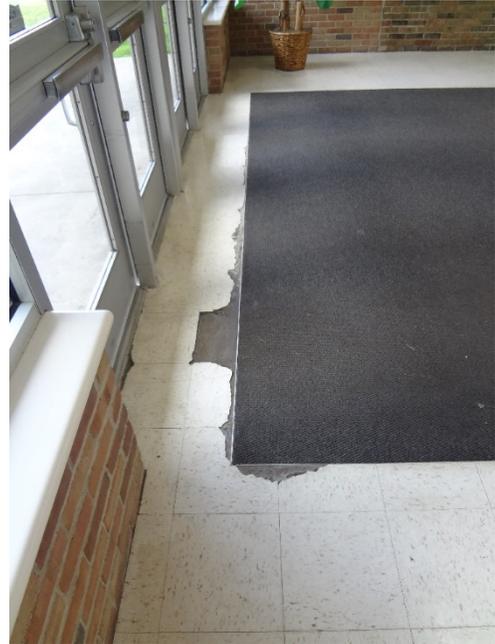
**18. BROKEN VCT AT VESTIBULE ENTRY FROM WATER INFILTRATING UNDER DOORS, TYPICAL
- STOP WATER INFILTRATION. FLOOR REPLACEMENT IN 2019, PART OF SINKNG FUND PROJECT**

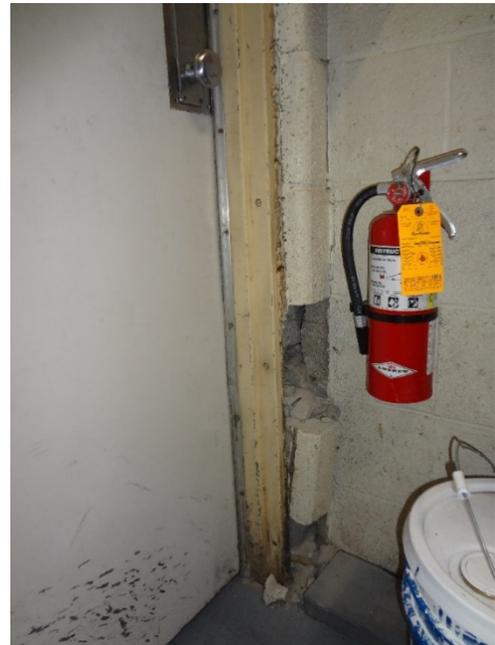
**19. BROKEN + MISSING CMU AT EXTERIOR DOOR FRAME
- CONSULT STRUCTURAL ENGINEER TO MONITOR AND DETERMINE REPAIR SOLUTION**

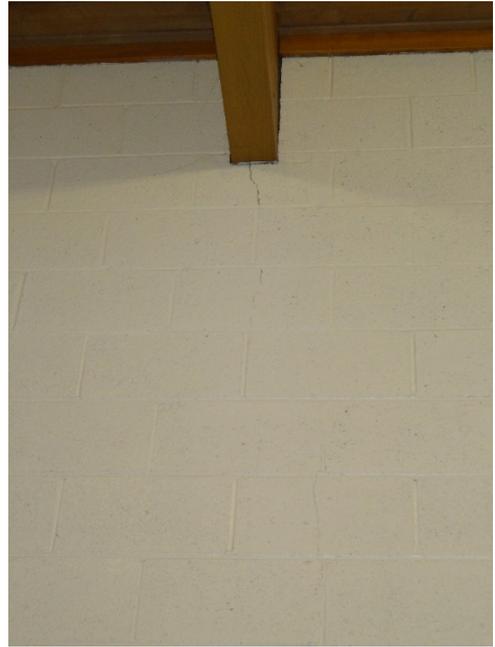
20. MASONRY CRACK OBSERVED ON SOUTH WALL AT LAMINATED WOOD BEAM
- CONSULT STRUCTURAL ENGINEER TO MONITOR AND DETERMINE REPAIR SOLUTION

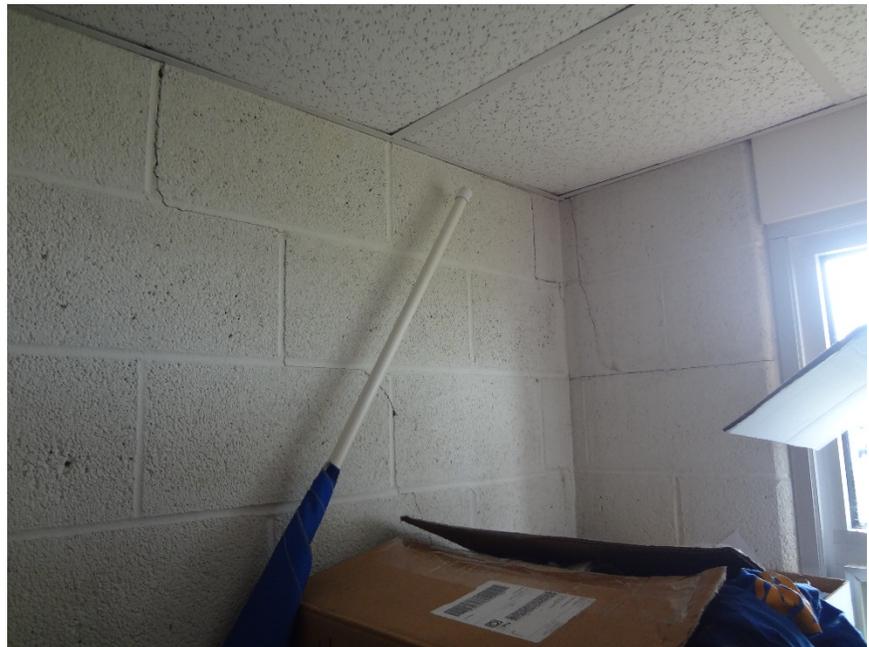
21. MASONRY CRACKS THROUGHOUT SOUTHEAST CORNER OF STORAGE ROOM
- CONSULT STRUCTURAL ENGINEER TO MONITOR AND DETERMINE REPAIR SOLUTION

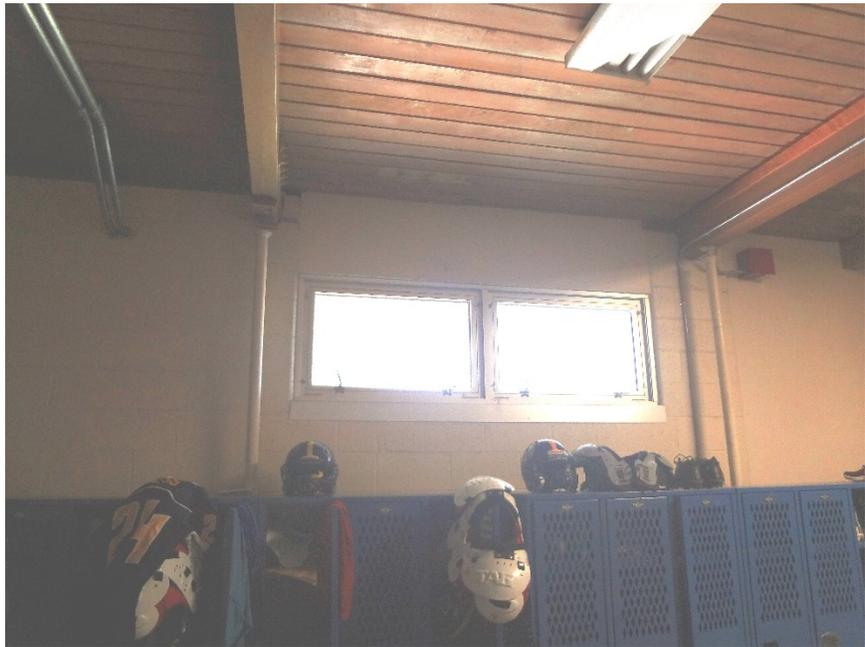
22. TWO RETROFIT STEEL JACKPOSTS AT LAMINATED WOOD BEAMS
- CONSULT STRUCTURAL ENGINEER. TO BE REPAIRED/REPLACED DURING 2019 REMODEL

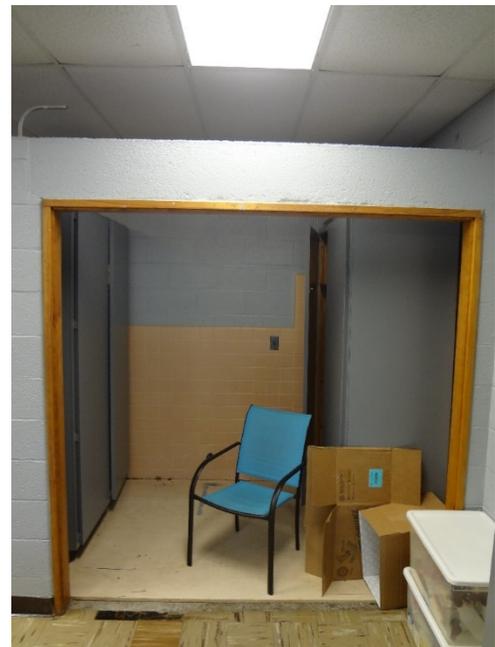
23. UNFINISHED DEMOLITION AND RENOVATION OF FORMER TOILET ROOM
- COMPLETE DEMOLITION OF SPACE, FINISH TO MATCH EXISTING CLASSROOM

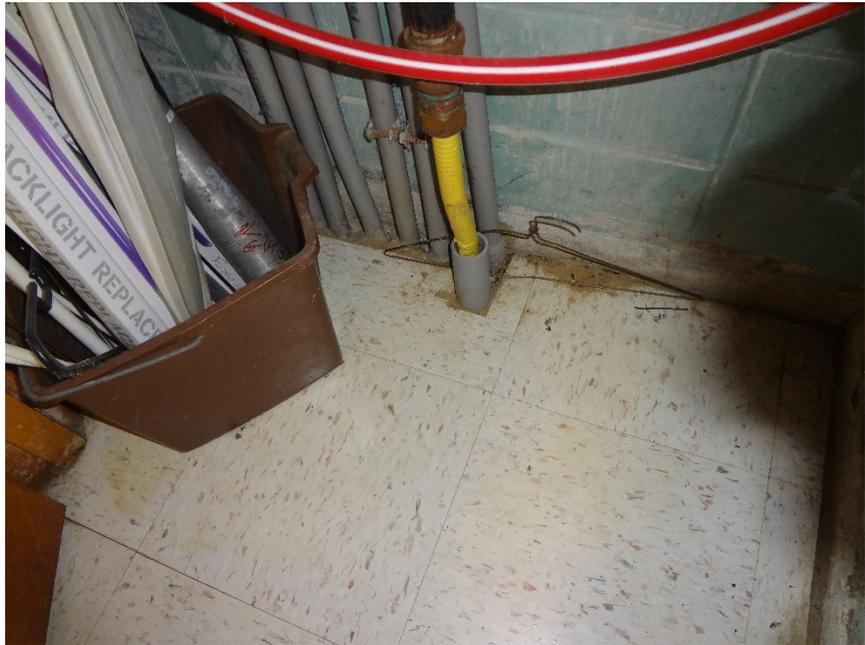
24. AREA OF WATER AND SAND INFILTRATION INTO CLASSROOM DURING HEAVY RAINS
- CAMERA (INSPECT) UNDERGROUND STORM LINE TO DETERMINE CAUSE, REPAIR

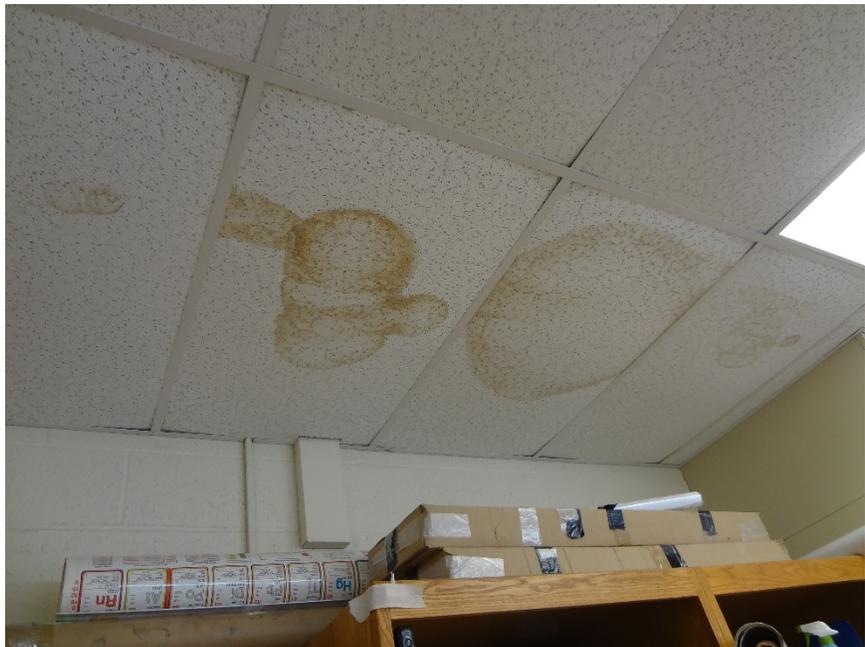
25. WATER STAINED CEILING TILES INDICATE A POTENTIAL OF WATER INFILTRATION AT ROOF
- INVESTIGATE SOURCE OF MOISTURE AND REPAIR. REPLACE CEILING TILES

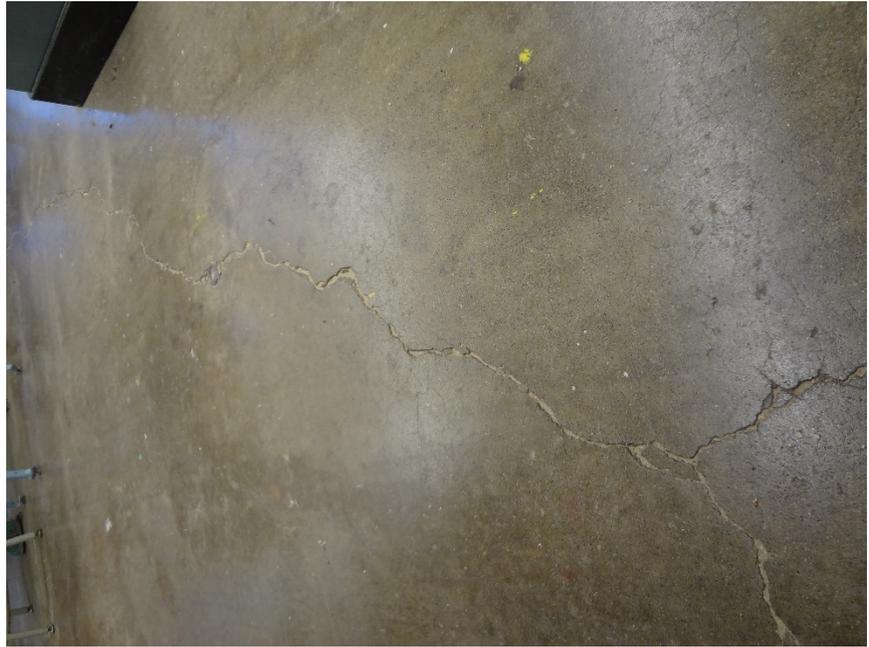
26. CRACKING IN CONCRETE FLOOR THROUGHOUT SHOP AREA
- CRACKING IS INHERENT IN CONCRETE. MONITOR FOR MOVEMENT, FINISH IF DESIRED

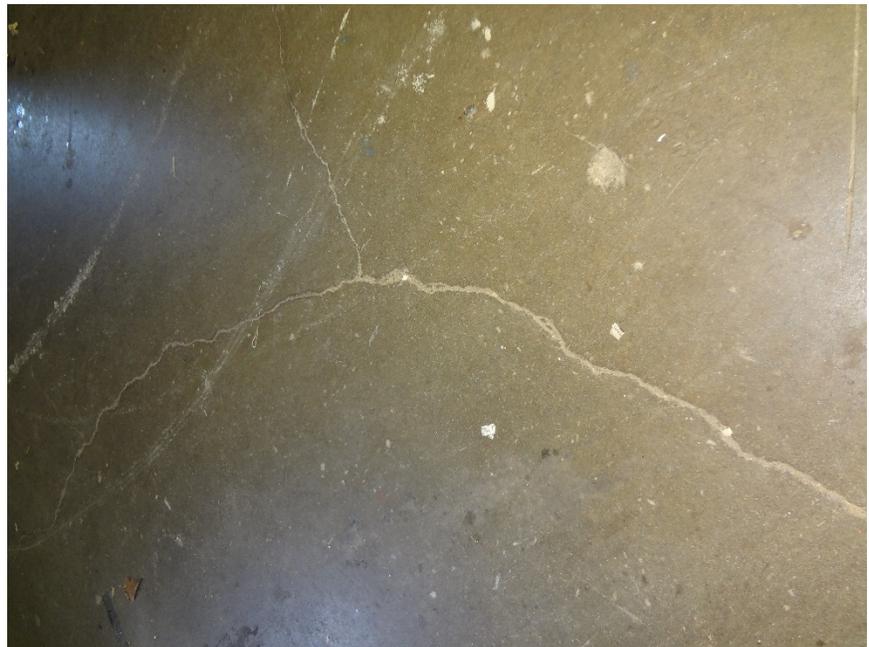
27. CRACKING IN CONCRETE FLOOR THROUGHOUT STORAGE AREA
- CRACKING IS INHERENT IN CONCRETE. MONITOR FOR MOVEMENT, FINISH IF DESIRED

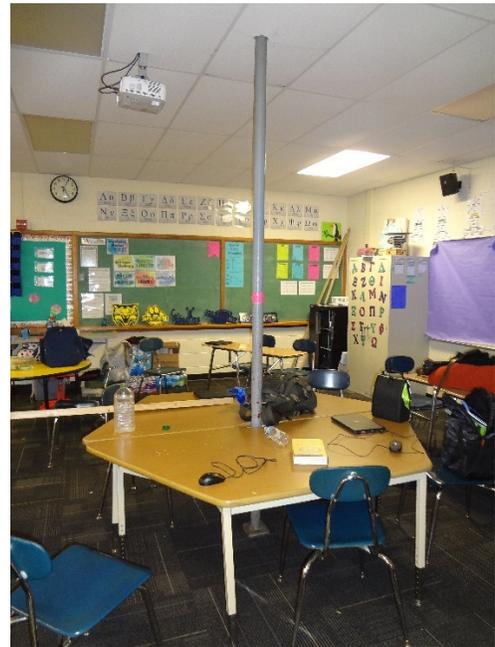
28. RETROFIT STEEL JACKPOST AT CENTER OF CLASSROOM
- CONSULT STRUCTURAL ENGINEER TO MONITOR AND DETERMINE REPAIR SOLUTION

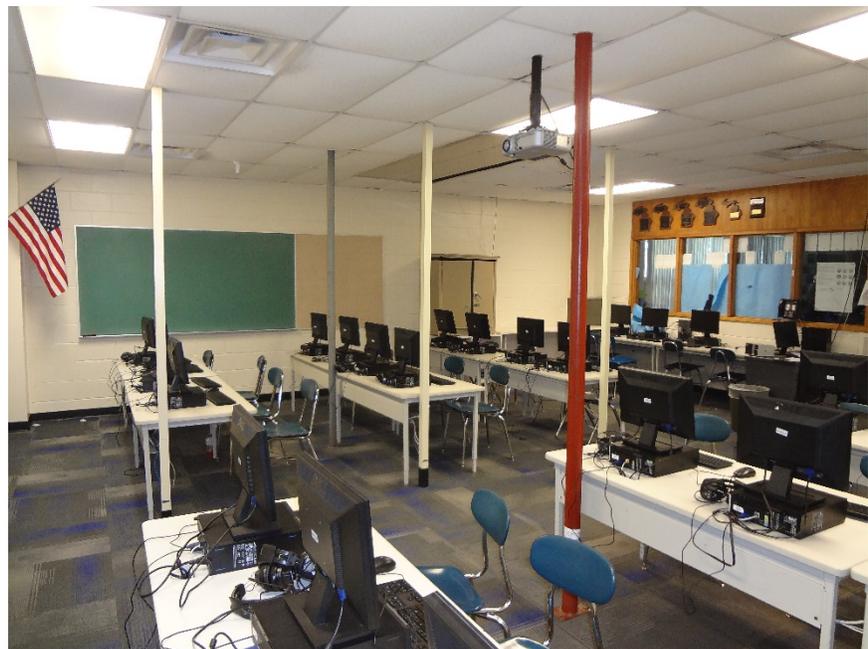
29. TWO RETROFIT STEEL JACKPOSTS AT CENTER OF COMPUTER LAB
- CONSULT STRUCTURAL ENGINEER TO MONITOR AND DETERMINE REPAIR SOLUTION

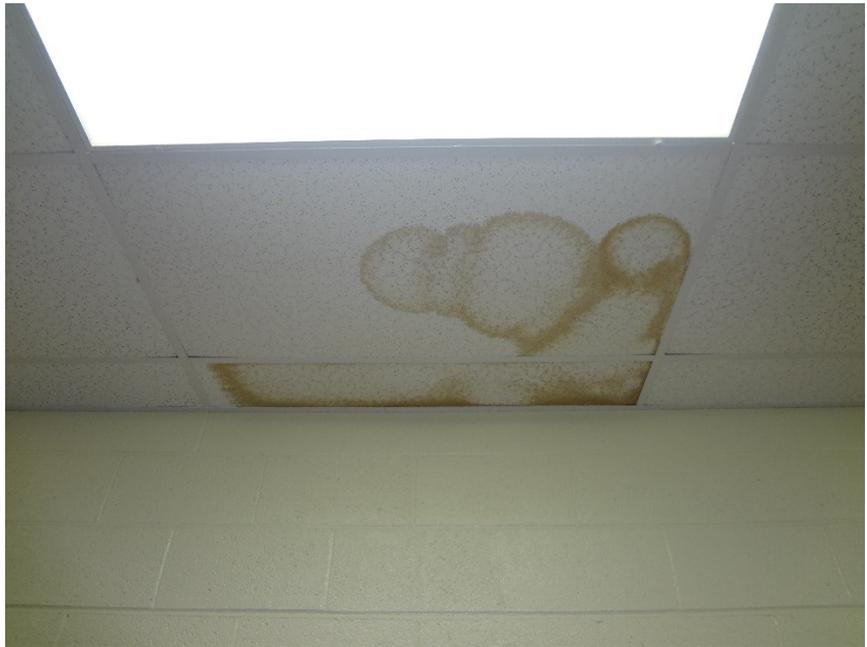
30. WATER STAINED CEILING TILES INDICATE A POTENTIAL OF WATER INFILTRATION AT ROOF
- INVESTIGATE SOURCE OF MOISTURE AND REPAIR. REPLACE CEILING TILES

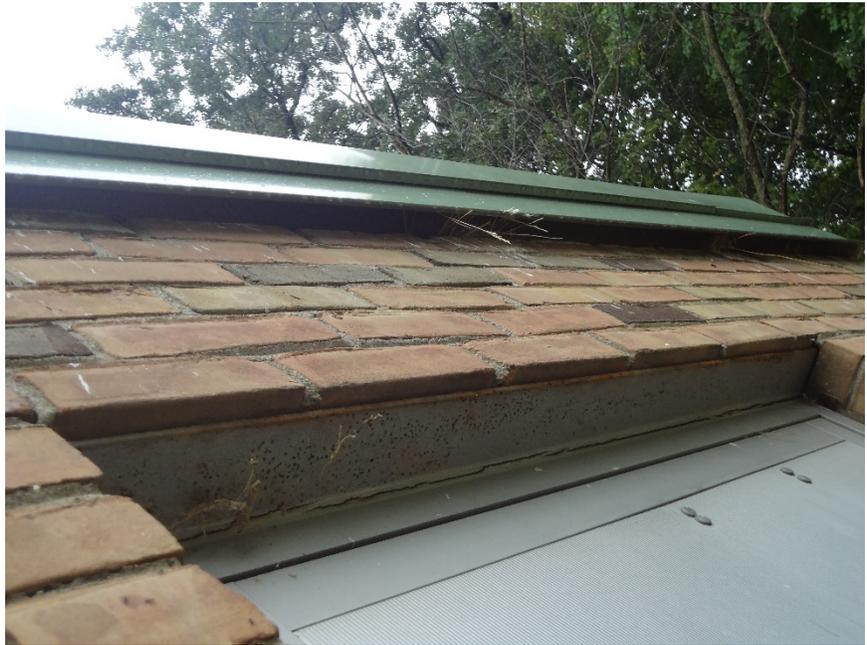
31. WIDE OPENING AT METAL ROOF FLASHING ALLOWING WEATHER INFILTRATION + NESTING
- CLEAN DEBRIS FROM OPENING AND INFILL FLASHING TO CLOSE AREA OF INFILTRATION

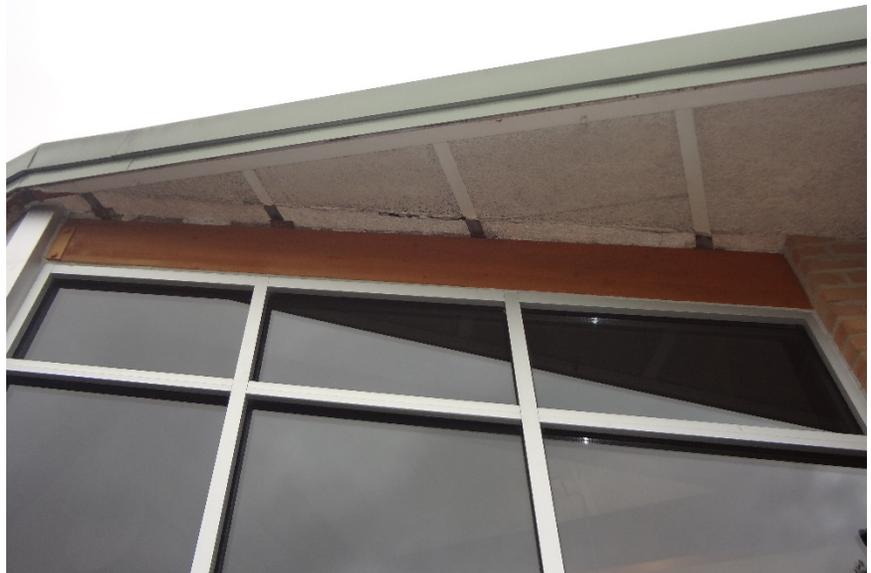
32. MISSING TRIM AT TECTUM SOFFIT EXPOSING STRUCTURE TO CORROSION + INFILTRATION
- REPLACE METAL SOFFIT TRIM AND ENSURE OPENING IS WEATHER TIGHT

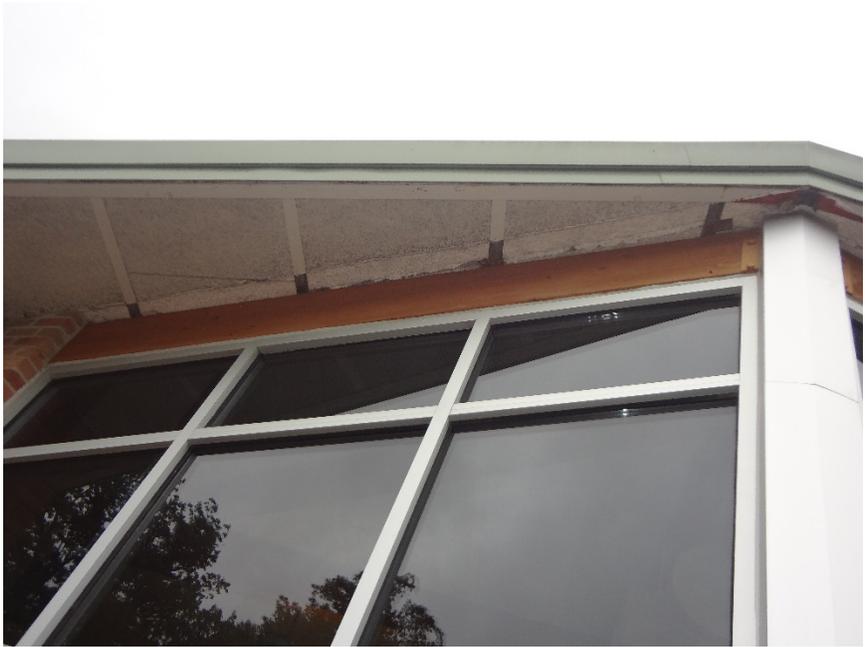
33. MISSING TRIM AT TECTUM SOFFIT EXPOSING STRUCTURE TO CORROSION + INFILTRATION
- REPLACE METAL SOFFIT TRIM AND ENSURE OPENING IS WEATHER TIGHT

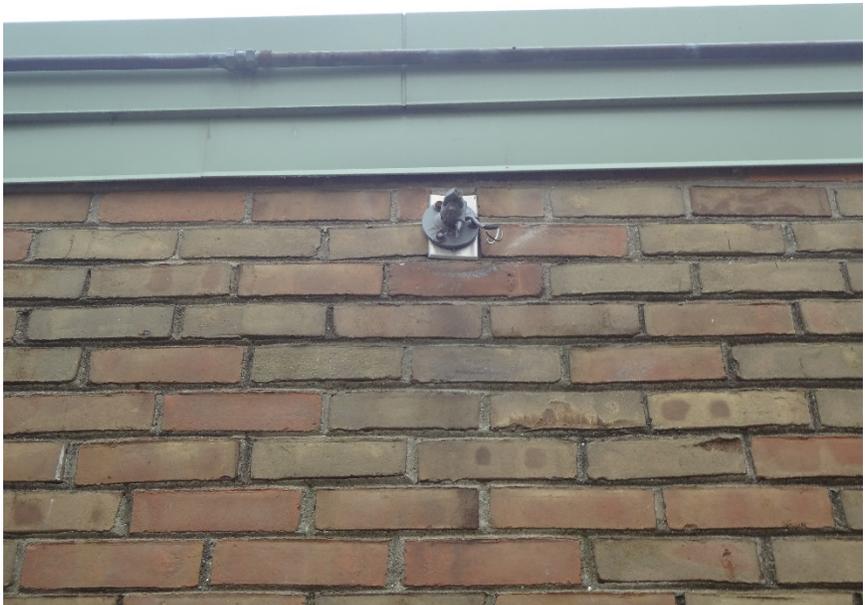
34. BROKEN EXTERIOR LIGHT FIXTURE ARM + MISSING EXTERIOR LIGHT FIXTURE
- REPLACE EXTERIOR LIGHT FIXTURE

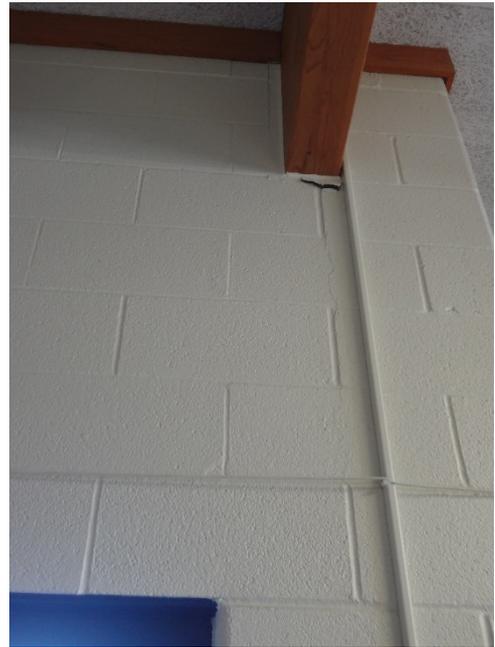
35. MASONRY CRACK OBSERVED ON WEST WALL OF ROOM 19 – ART.
- CONSULT STRUCTURAL ENGINEER TO MONITOR AND DETERMINE REPAIR SOLUTION

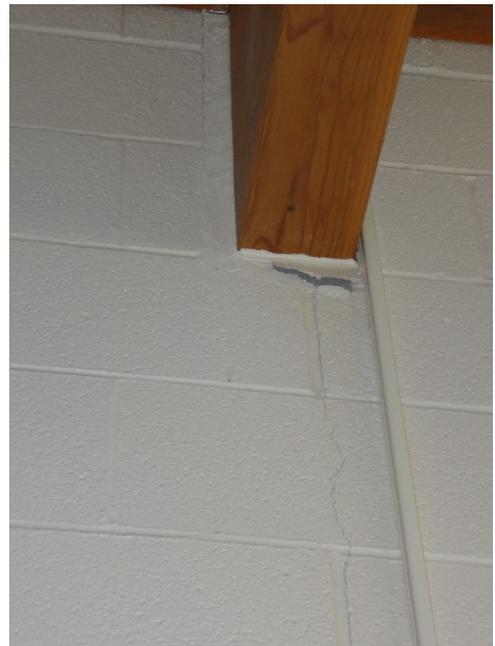
36. ENLARGED IMAGE OF MASONRY CRACK OBSERVED ON WEST WALL OF ROOM 19 – ART.
- CONSULT STRUCTURAL ENGINEER TO MONITOR AND DETERMINE REPAIR SOLUTION

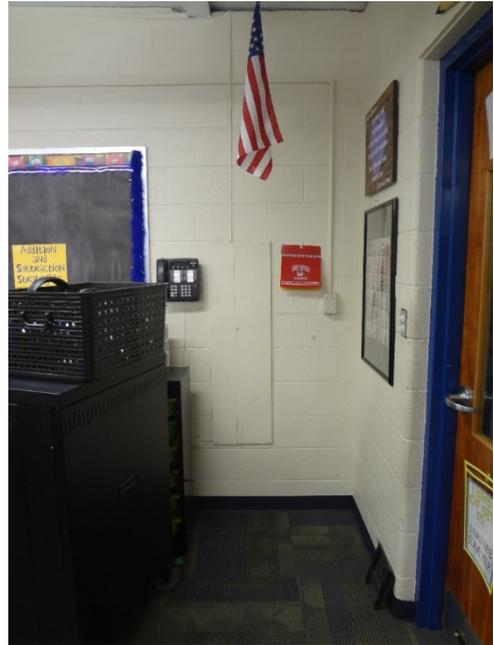
37. WOOD PANEL COVERING CMU WALL OPENING
- REMOVE PANEL, INVESTIGATE PURPOSE, REPAIR OPENING WITH MASONRY

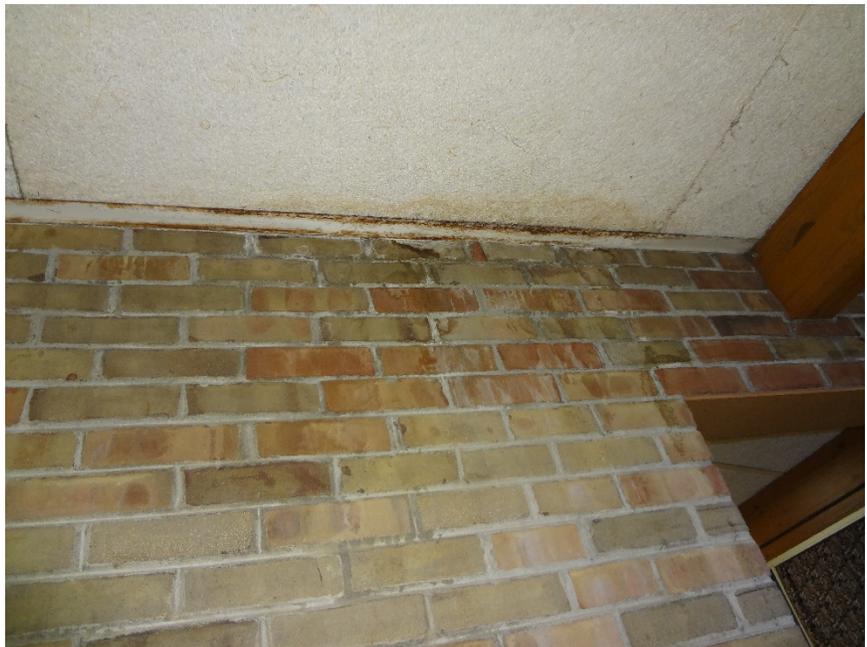
38. CORROSION OF METAL FRAMING, STAINING FROM MOISTURE INFILTRATION
- INVESTIGATE SOURCE OF MOISTURE AND REPAIR. CLEAN BRICK AND CEILING ASSEMBLY

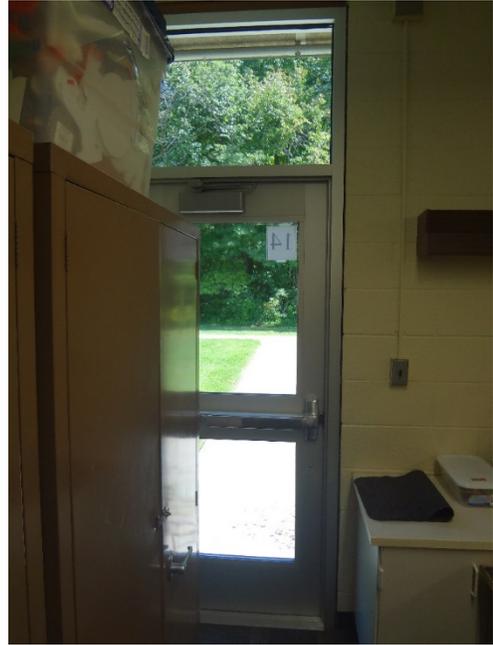
39. MISSING BACKER ROD + SEALANT AROUND ENTIRE DOOR FRAME
- INSTALL BACKER ROD AND CAULK AROUND FRAME, INSPECT WEATHERSTRIPPING

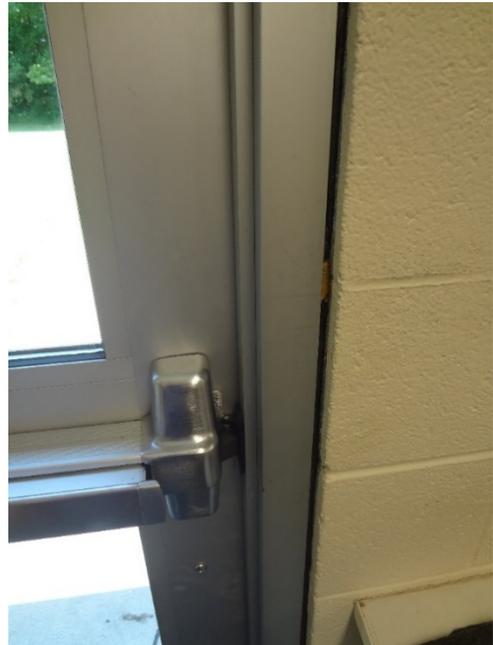
40. ENLARGED IMAGE OF MISSING BACKER ROD + SEALANT AROUND DOOR FRAME
- INSTALL BACKER ROD AND CAULK AROUND FRAME, INSPECT WEATHERSTRIPPING
